Successful Deployment of Surveillance Systems for Atomic Minerals Directorate for Exploration and Research (AMD) in Hyderabad and Bangalore

About the Project:

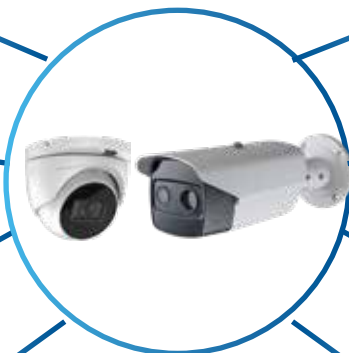
Network Cameras

A total of 57 high-tech cameras now vigilantly oversees the premises:

4MP 40m IR Dome 32 units strategically placed for wide-area monitoring.

4MP 60m IR Bullet: 20 units enhancing security with extended IR range.

4MP 90m IR Bullet: 3 units providing long-distance clarity.

150m IR PTZ: 2 units offering dynamic and comprehensive coverage.

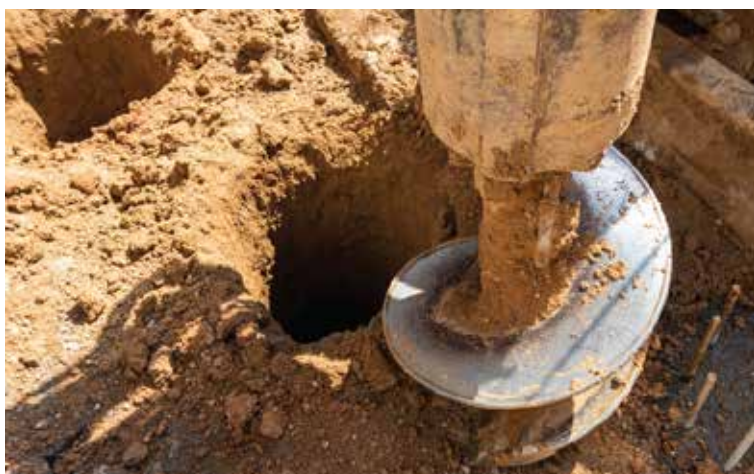
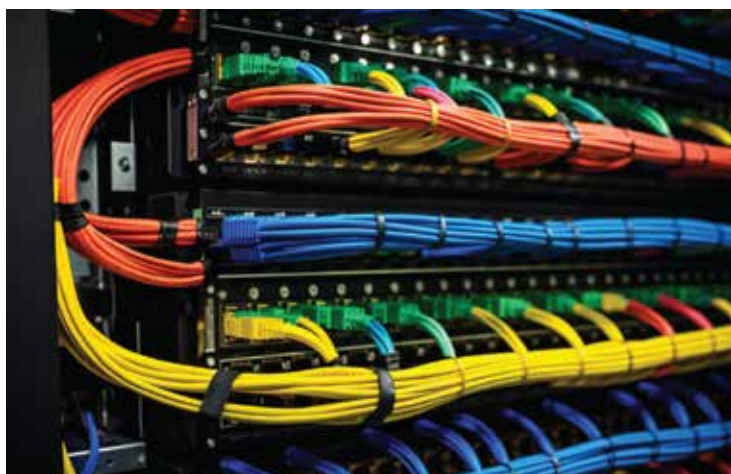
Challenge: Preventing damage to existing underground utilities like water pipes, electrical cables, and telecommunications lines.

Solution: Conducted thorough underground surveys to identify utility locations and planned alternative routes where necessary.

Challenge: Digging through various soil conditions such as rocky, sandy, or clay.

Solution: Deployed heavy machinery for rocky soils and adapted digging techniques as per soil types.
